Crescent Lake Watershed Based Management Plan

PROJECT NO.

20241075

This project was undertaken by Stone Environmental, Inc. for the Crescent Lake Association.

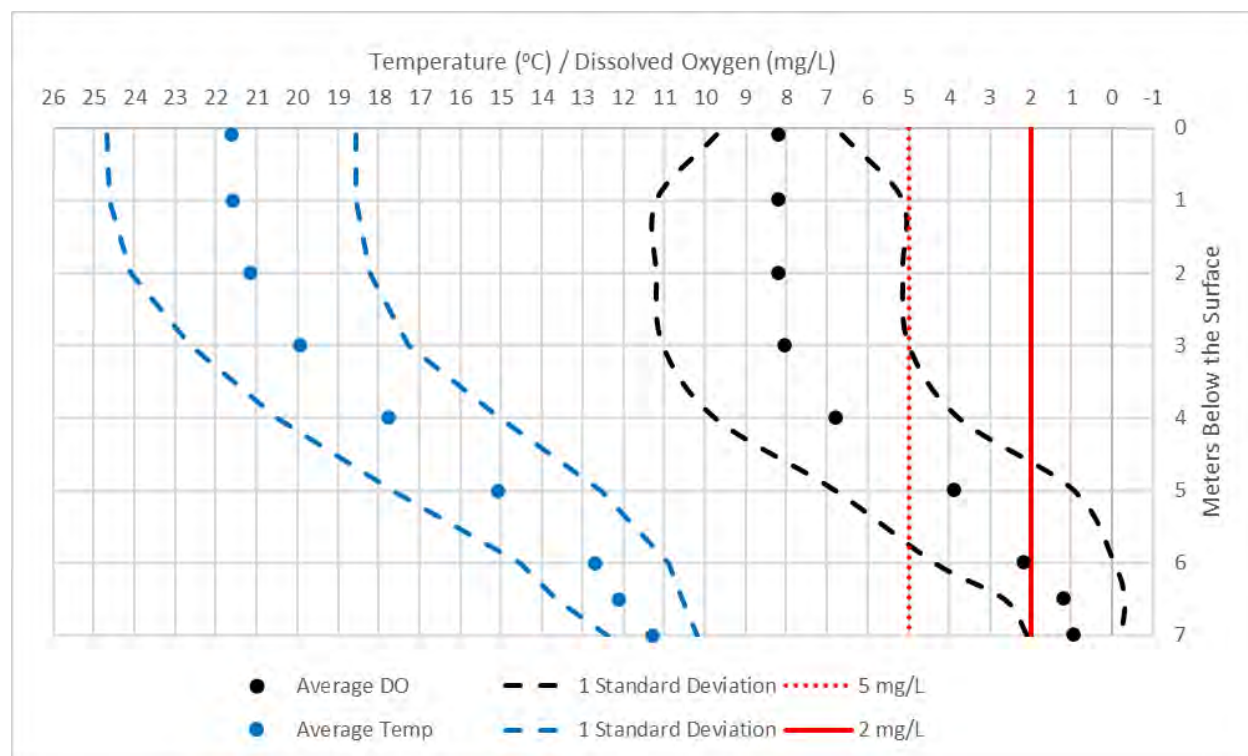
Summer dissolved oxygen trends in Crescent Lake have remained consistent since the 1990s. Vertical profiles of dissolved oxygen concentration have historically been collected once per summer, with epilimnion concentrations averaging 8 mg/L and hypolimnion concentrations averaging as low as 1 mg/L as shown in Figure 8. This suggests organisms are consuming oxygen and that there is the potential for release of sediment-bound phosphorus.

Figure 8. Dissolved oxygen profile summary 1990 to present.

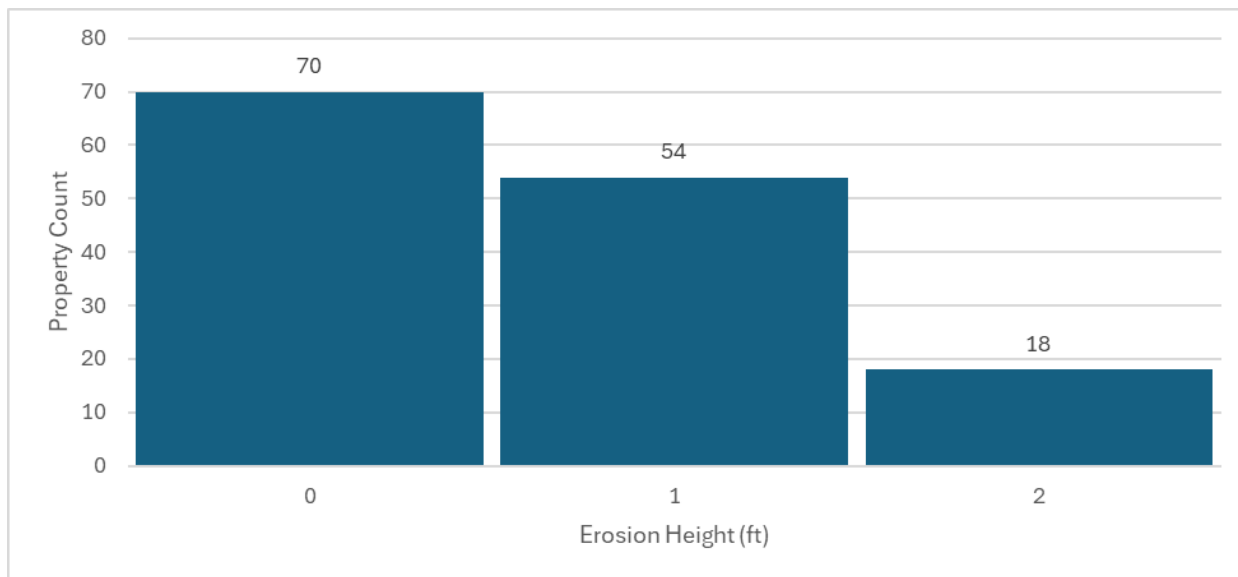
Figure 16. Histogram of Crescent Lake shoreline erosion.
